The Measurement and Modeling of a World War I Mark IV Tank Using CLR and CCD Camera/Line Scanning Systems in an Outside Environment

The process of measuring, documenting, and reproducing the dimensional aspects of antiquities in an outside environment requires an intricate set of protocols. This paper details some of those protocols as demonstrated in the recent scanning of a historic British Mark IV World War I tank using state-of-the-art metrology systems, including coherent laser radar (CLR) and charge-coupled device (CCD) camera/line scanner technologies. The effort was part of project to help document, preserve, and restore the weather-damaged vehicle. Originally named “Britannia,” the Mark IV saw heavy combat (and success) in the Battle of Arras, France, on the Western Front. The tank and its crew were then sent to the United States to support war bond rallies (where it was renamed “Liberty” in appreciation of American participation). Finally, in 1919, the tank became a cornerstone attraction at the Army's newly established U.S. Army Ordnance Museum at Aberdeen Proving Ground, MD, where it has been on outdoor display for nearly 90 years. Today, the vehicle is scheduled to be

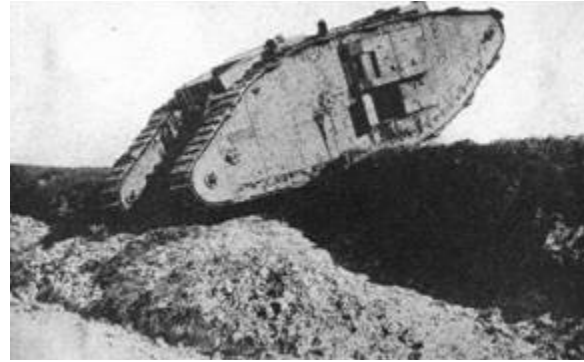
Figure 1. Mark IV Testing at Bovington, England

As shown in Figure 1, Liberty has a distinctive parallelogram-type shape. It measures approximately 26.4 ft long, 10.5 ft wide, and 8.2 ft high and has a 16.5-in ground clearance. When fully combat loaded (including four crew and 13,000 rounds of ammunition), it weighed over 30 tons and exerted a ground pressure of 12.8 lbs/in². It had a radius of action of 15 miles and was capable of crossing a 10-ft-wide trench, scaling a 54-in obstacle, and climbing a 22° (40%) slope.

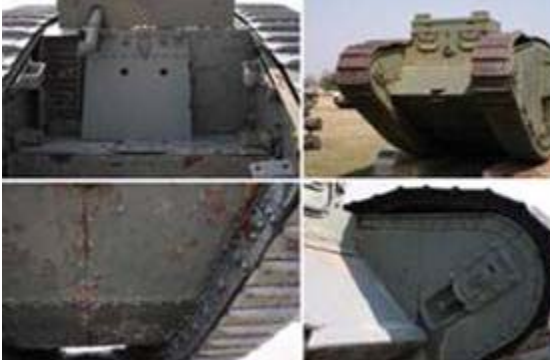
Figure 5. Tank Surfaces and Details

Liberty is a large, intricate machine. To meet the requirements of documenting the mechanical details of such a machine, accuracy was considered the most important aspect in the measurement process. In conjunction with documenting the tank's dimensions, it was critical to provide extremely accurate data for analyzing the tank's structural condition. With large surface areas and detailed fabrication features (see Figure 5), issues such as point cloud densities, data processing limitations, and file sizes also had to be considered when choosing scanning technologies. Although these considerations limited the technologies available to achieve the goals of this project, two scanning systems were identified as being capable of producing acceptable results.

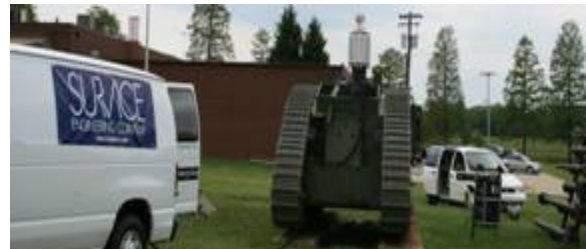
Figure 8. Field Conditions Typical During Scanning

Liberty was scanned in its existing display location in the Ordnance Museum's field of armor. As shown in Figure 8, the tank rests on two concrete foundation strips, with the surrounding area consisting of grass-covered, compacted soil. During scanning, both the tank and scanning equipment were exposed to direct sunlight and ambient weather conditions. Environmental conditions and the tank's surface measurements were monitored throughout the process. These measurements were used in post-processing for scaling point cloud and surface data for material expansion compensation.

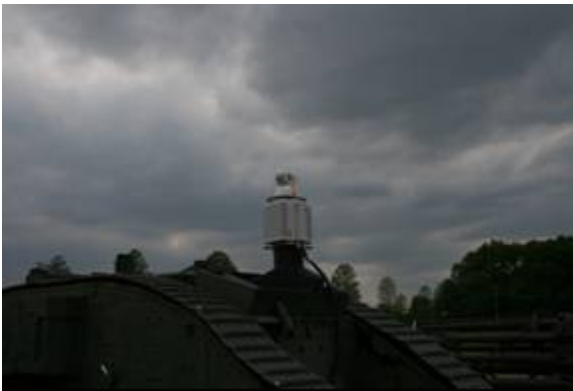
Figure 9. Threatening Weather

Considering all the unique conditions encountered during this project, perhaps the most important aspect of planning the task involved exposing the half-million-dollar equipment to Maryland's springtime weather. Thus, a critical element of the project's measurement plan was to continuously monitor weather conditions and be ready to quickly relocate the equipment to shelter in the metrology van or nearby museum building (where the equipment was stored overnight). As it turned out, the metrology team encountered no rain during the scanning process, but threatening clouds on the last day were cause for considerable concern (see Figure 9).

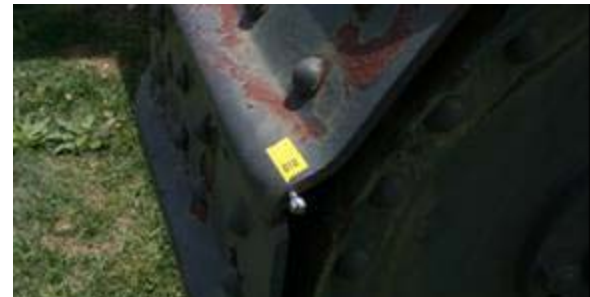
Figure 10. CNM (Tooling Ball) Locations

Another part of the project that had to be addressed before actual data collection could begin was the establishment of a control network for the previously mentioned scan technologies to share. The CLR chosen for this work performs best using 1/2-inch-diameter (12.7 mm) tooling balls, noted as control network monuments (CNM). Thus, an arrangement of CNMs was placed on the tank such that each instrument location was assured of "seeing" a minimum of six CNMs when transforming into the coordinate frame (see Figure 10). For the tank's interior (which was not completely measured due to time and resource limitations), the scanners measured through the open doors below the sponsons (side turret assemblies) to value CNMs and took numerous surface scans for reference.

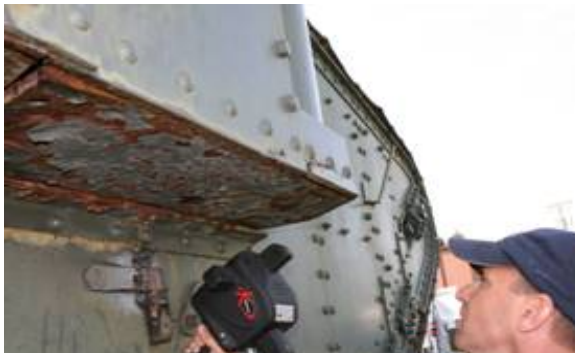
Figure 13. K-Scan Measurement of Sponson Bottom

In addition, line scanning was used to detail exterior features and provide supplemental data in areas where the CLR could not access low surfaces. These exterior scanning activities, using the K-Scan system, were accomplished by locating the CCD camera bar along the longitudinal axis of the tank near the front. In this position, the line scanner was used to measure the areas under the gun sponson (Figure 13).

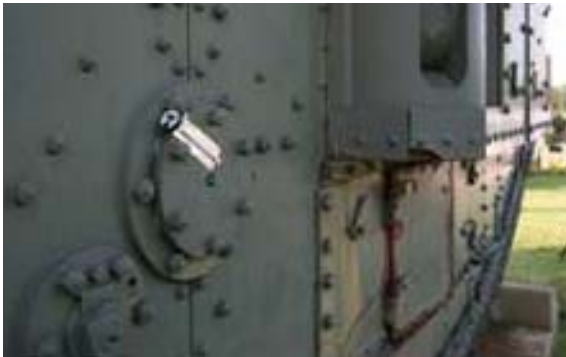
Figure 15. Surface Temperature Monitoring

Environmental conditions for the 4 days of scanning are shown in Figure 14. Extremes in temperature and humidity, as well as comments regarding dew, ground conditions, and cloud cover, were also recorded. As shown in Figure 15, the tank’s surface temperatures were continuously monitored to determine the variation during scanning activities and the difference between direct sunlight and shaded surfaces (which, during mid-day activities, was between 15° and 20° C (27° and 45° F). All temperature-related observations were time-stamped for reference in generating temperature compensation during the post-processing activities.

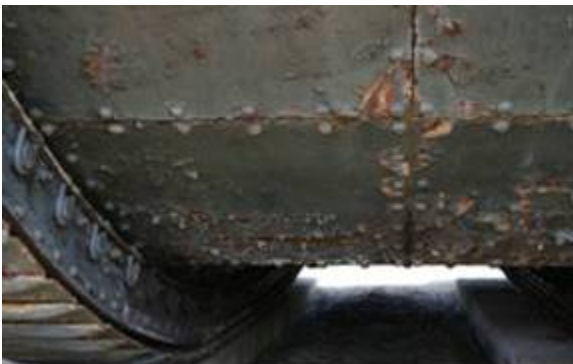
Figure 16. Corrosion and Flaking on Bottom Plates

Structural details were also inspected to determine the tank’s conditions in connection areas exposed during the scanning activities (see Figure 16). This supplements the structural analysis of the steel members and armor plate. Ultimately, the findings are dependent on the final processed data and will be supporting conclusions needed by the museum for the tank’s movement and restoration..

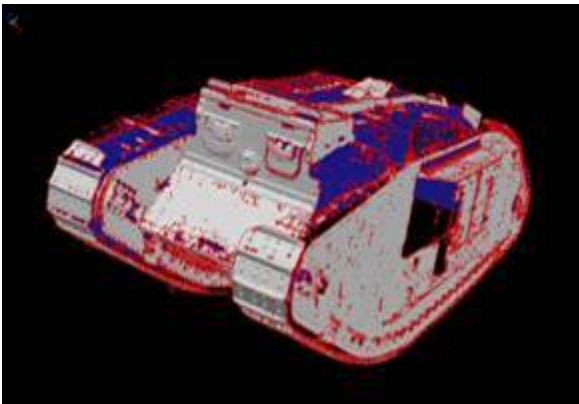
Figure 18. Locations of Missing Surface Data (in Red)

Note that the generation of the watertight model took extra steps due to the inaccessibility of certain surfaces. For instance, the modeling of tank tread on the bottom of the vehicle required the generation of a track/rievet surface, then fitting it to the bottom side of the track. This work carried to other surfaces on the top and particularly rear details. Figure 18 highlights locations on Liberty where scan data are missing (and where follow-up scans are needed).
