MARK IV TANK

ISSUE: Capture the dimensional condition of the U.S. Army Ordnance Museum's World War I Mark IV tank to support restoration efforts.

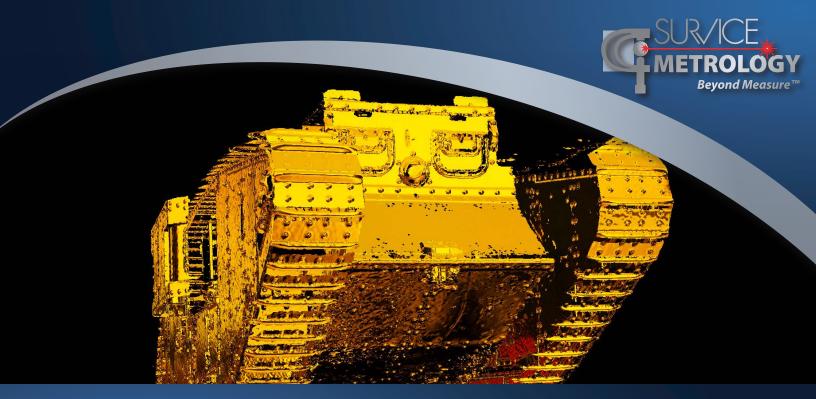
team, using a Coherent Laser Radar and a Handheld Optical CMM Scanner, collected 8 million points over 4 days on the Ordnance Museum's Mark IV tank located in its outdoor display. Spatial Analyzer and PolyWorks software were used to develop a surface model (4 million polygons) of the tank.
